## Stone monuments and abandoned quarries –ways of restoration in Germany through times

**Angela Ehling**

**Rainer Ebel**

**Citation:** Ehling, A., Ebel, R. (2026). Stone monuments and abandoned quarries – ways of restoration in Germany through times. *Boletín Geológico y Minero*, 137(1), 008. <http://dx.doi.org/10.21701/bolgeomin/137.1/008>

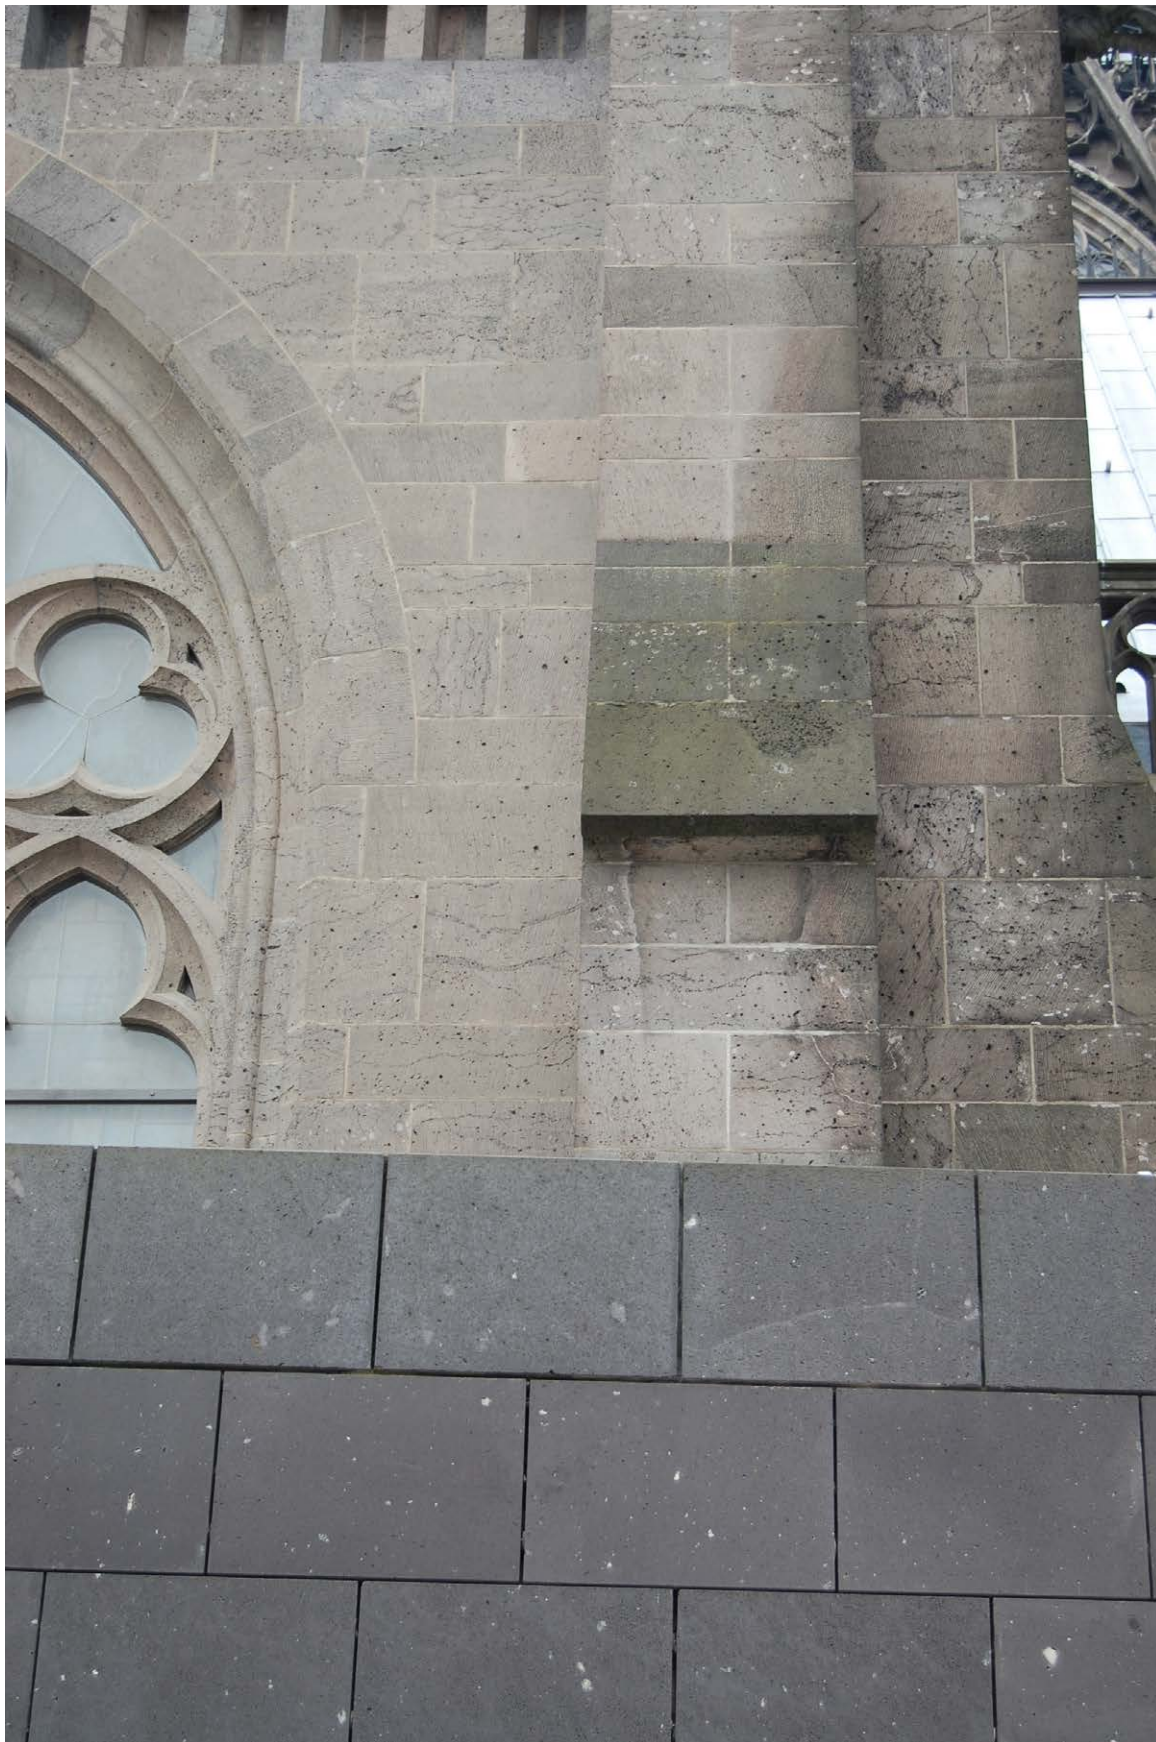
Figure 2. Original Drachenfels trachyte in the upper part and Londorf basaltlava as a replacement in the lower part at the Cologne Cathedral (photo Angela Ehling).

One of the best-known examples is Cologne Cathedral, one of Germany's stone landmarks and since 1996 recognized as UNESCO world Heritage site (<https://whc.unesco.org/en/list/292>). It was built over centuries from 1248 to 1880 with a long interruption of 300 years between the 16<sup>th</sup> and the 19<sup>th</sup> century. In 1842 the completion of the cathedral started as a national task. The dominant building stone of the old parts was Drachenfels trachyte (44 kilometres away), which was quarried already by the Romans and transported to Cologne and other cities via the Rhine. This was probably the first time that the problem of an unavailable building rock for a prominent building arose, as the Drachenfels and therefore also the quarries had been a nature reserve since 1836 - one of the first nature reserves in Germany. There is hardly any similar stone like this trachyte in Germany (Fig. 2).

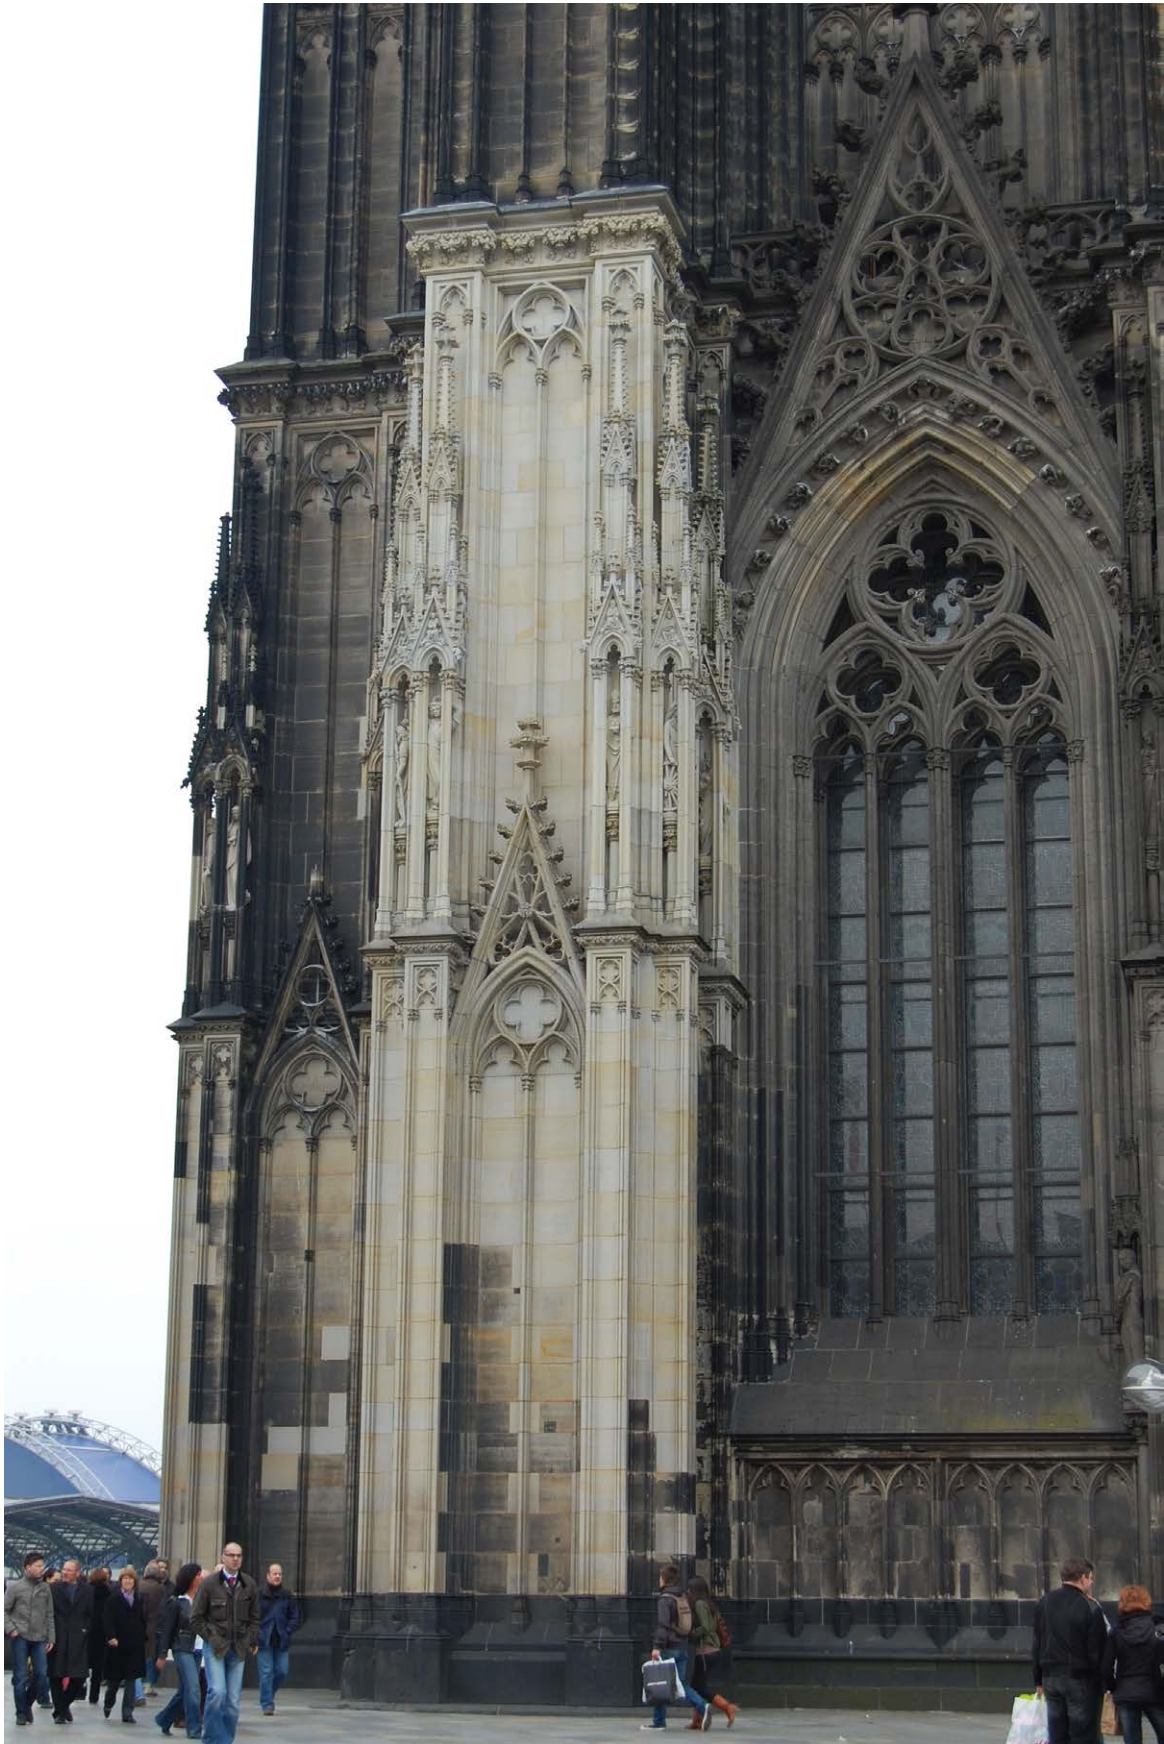
Figure 3. White Obernkirchen sandstone as a replacement stone at the Cologne Cathedral (photo Angela Ehling).  
Figura 3. Arenisca blanca de Obernkirchen como piedra de reemplazo en la Catedral de Colonia (foto de Angela Ehling).

For this reason, both the construction phase, from 1842 to 1880, and the later restoration phases were characterised by the constant search for replacement stones. During the completion phase, other volcanic rocks in the surrounding area were first used and finally 11 different sandstones from several parts of Germany were used. This period is called the "sandstone age of the Cologne Cathedral" (Fig. 3).

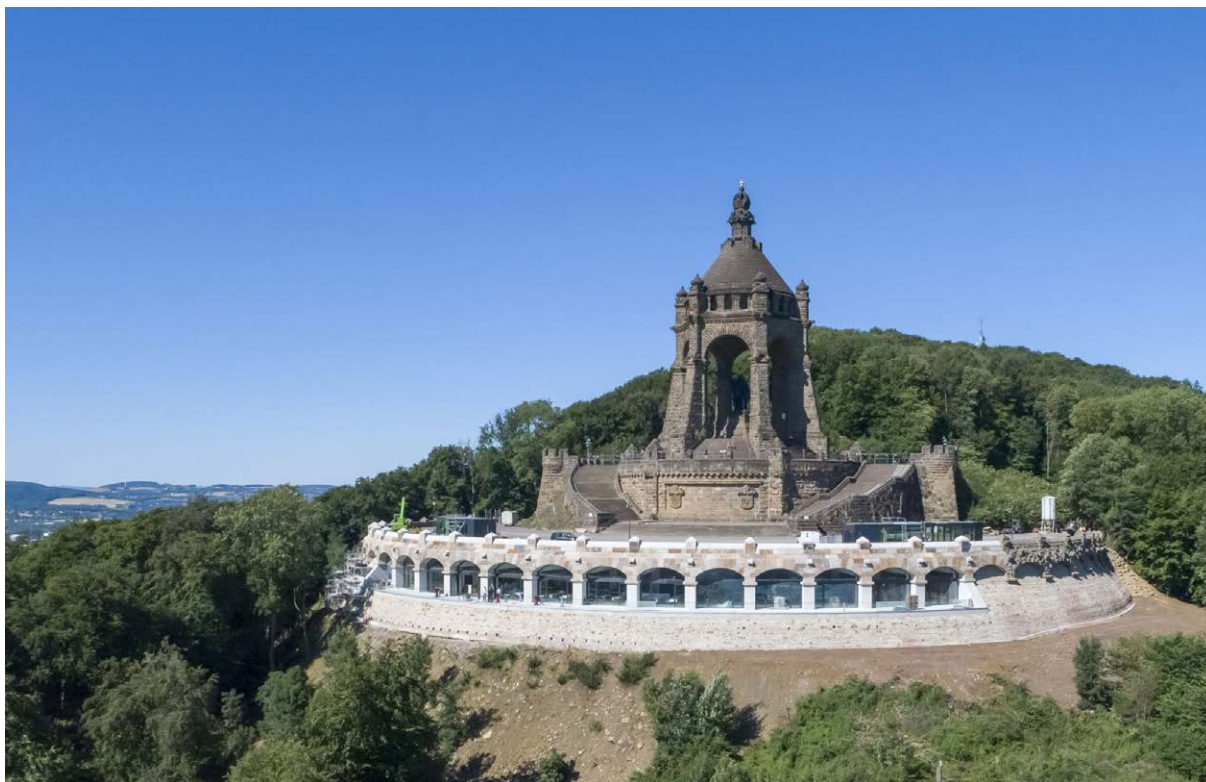
Figure 4. Monument Kaiser Wilhelm at Porta Westfalica with original brown Porta sandstone at the monument and new white Obernkirchen sandstone at the wall (photo Peter Hübbe).

The decision in favour of this sandstone, which was not really suitable, was accompanied by the comment in the press that after decades it would take on a dark surface anyway and the difference would no longer be perceptible from a distance (Fig. 4) (Beyer, 2018).

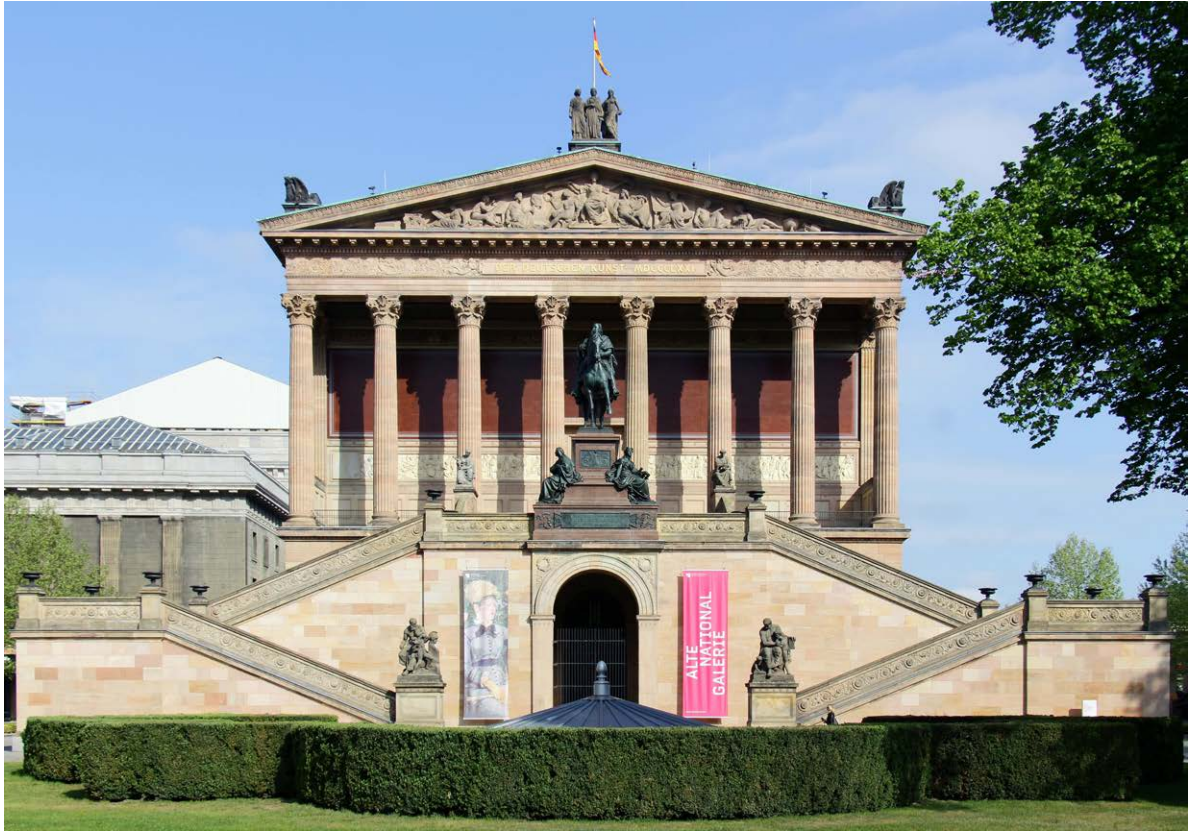
This museum was the third built museum at the Museum Island in Berlin; UNESCO World Heritage since 1999 (<https://whc.unesco.org/en/list/896>). It was built between 1866 and 1876, with architecture reminiscent of a Greek temple. All facade and architectural elements were made of a Buntsandstein from Nebra, a little village in Sachsen-Anhalt at the river Unstrut (Fig. 5). The last quarries there closed in the 1960s. Suitable replacement stones were sought as part of the extensive restoration around 1990. The Nebra sandstone offered a wide variety of colours: white, grey, light yellow, pink, salmon-coloured and red. The facade is dominated by pink and salmon-coloured varieties. Sandstones with these colours could not be provided by other quarries. For this reason, two companies reopened quarries near Nebra and supplied the required replacement stones. It was a direct co-operation between the Office for the Preservation of Historical Monuments and the quarry companies (Ehling & Siedel, 2011). One of the quarries is still open for restoration purposes (Fig. 6).

Figure 5. Alte Nationalgalerie at the Museums Island in Berlin (photo Ulf Schönitz).  
Figura 5. Alte Nationalgalerie en la Isla de los Museos en Berlín (foto de Ulf Schönitz).

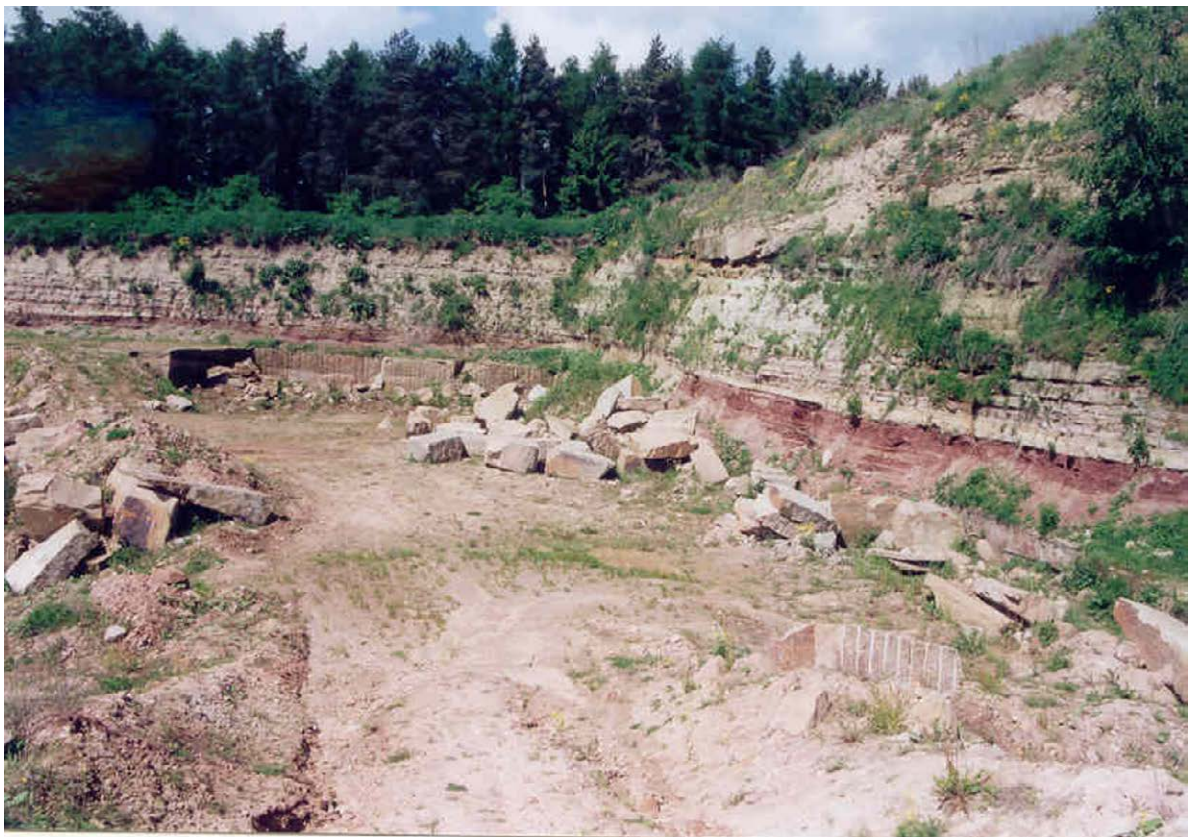
Figure 6. Sandstone quarry near Nebra; extraction almost only for restoration purpose (photo Angela Ehling).  
Figura 6. Cantera de arenisca cerca de Nebra; extracción casi exclusivamente con fines de restauración (foto de Angela Ehling).

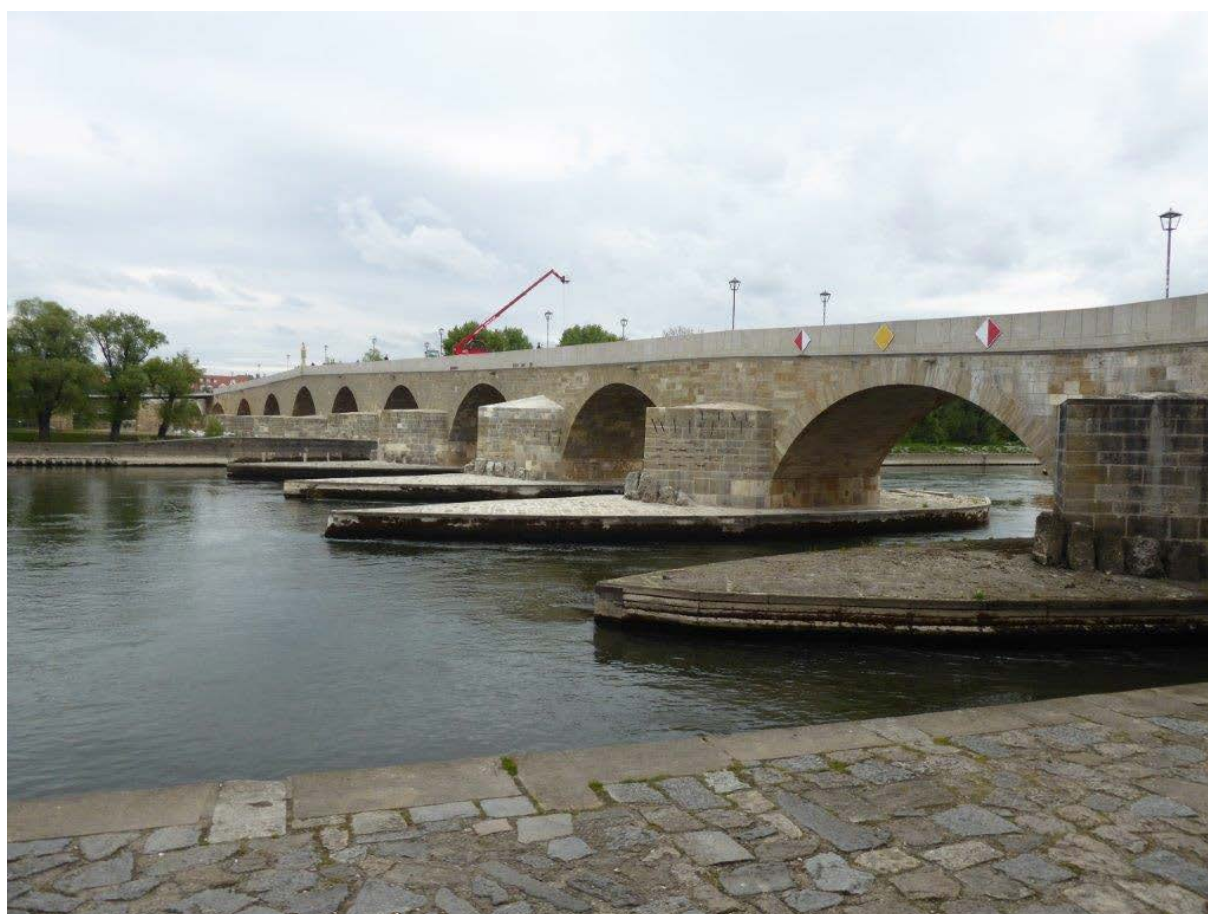
Figure 7. Stone bridge in Regensburg after restoration with new granite railing (photo Klaus Poschlod, 2018).

Finally, for reasons that are not clear, the restorers decided to use a granite for replacement (Fig. 7).

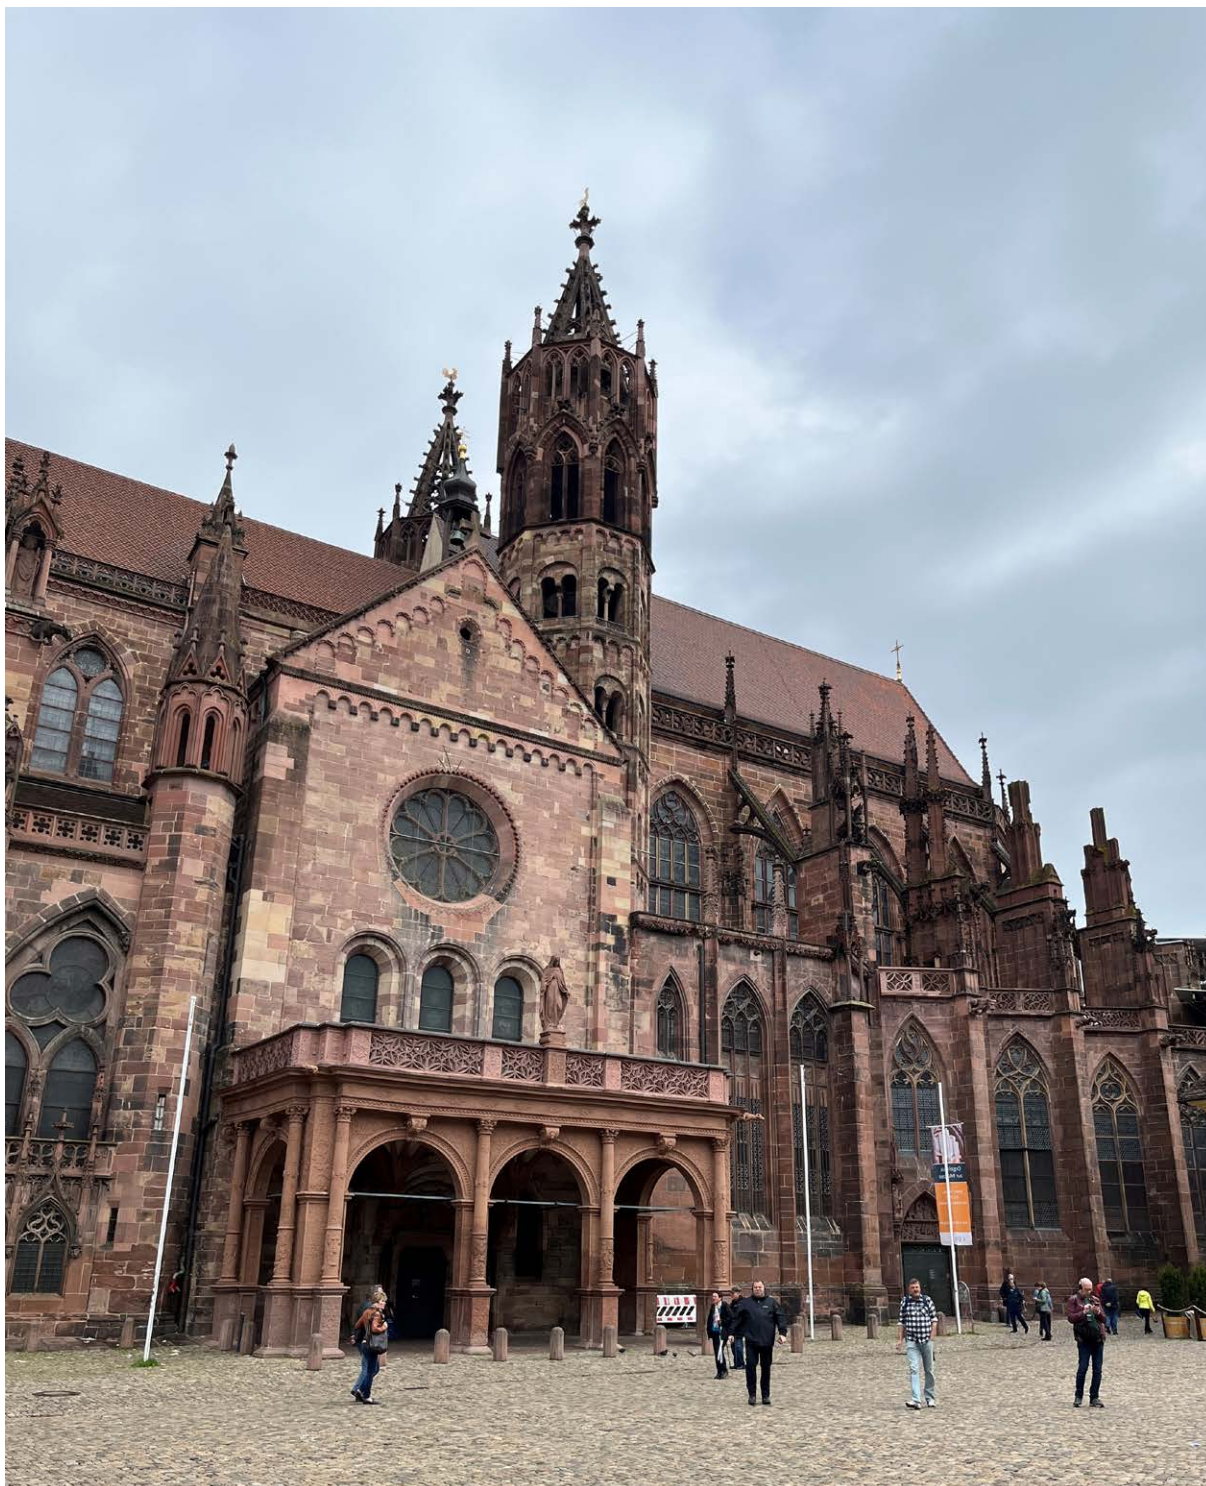
Freiburg Münster (1200-1513), although started in the Romanesque style, is considered a masterpiece of Gothic architecture, especially, its beautiful west tower. The impression of a work of art from a single mould is largely determined by the building stones, which over the 300 years of construction, mainly consists of red and yellow Bunter sandstone (Fig. 8). After several years of research in archives

and investigations of the sandstones from historical quarries in the surrounding area, various quarries were identified as suppliers of building stone in different construction phases. In the 20<sup>th</sup> century, sandstone from more distant regions was used for repair work, as the historic quarries were no longer in production or could no longer supply suitable material.

Figure 8. Freiburg Münster (photo Angela Ehling).

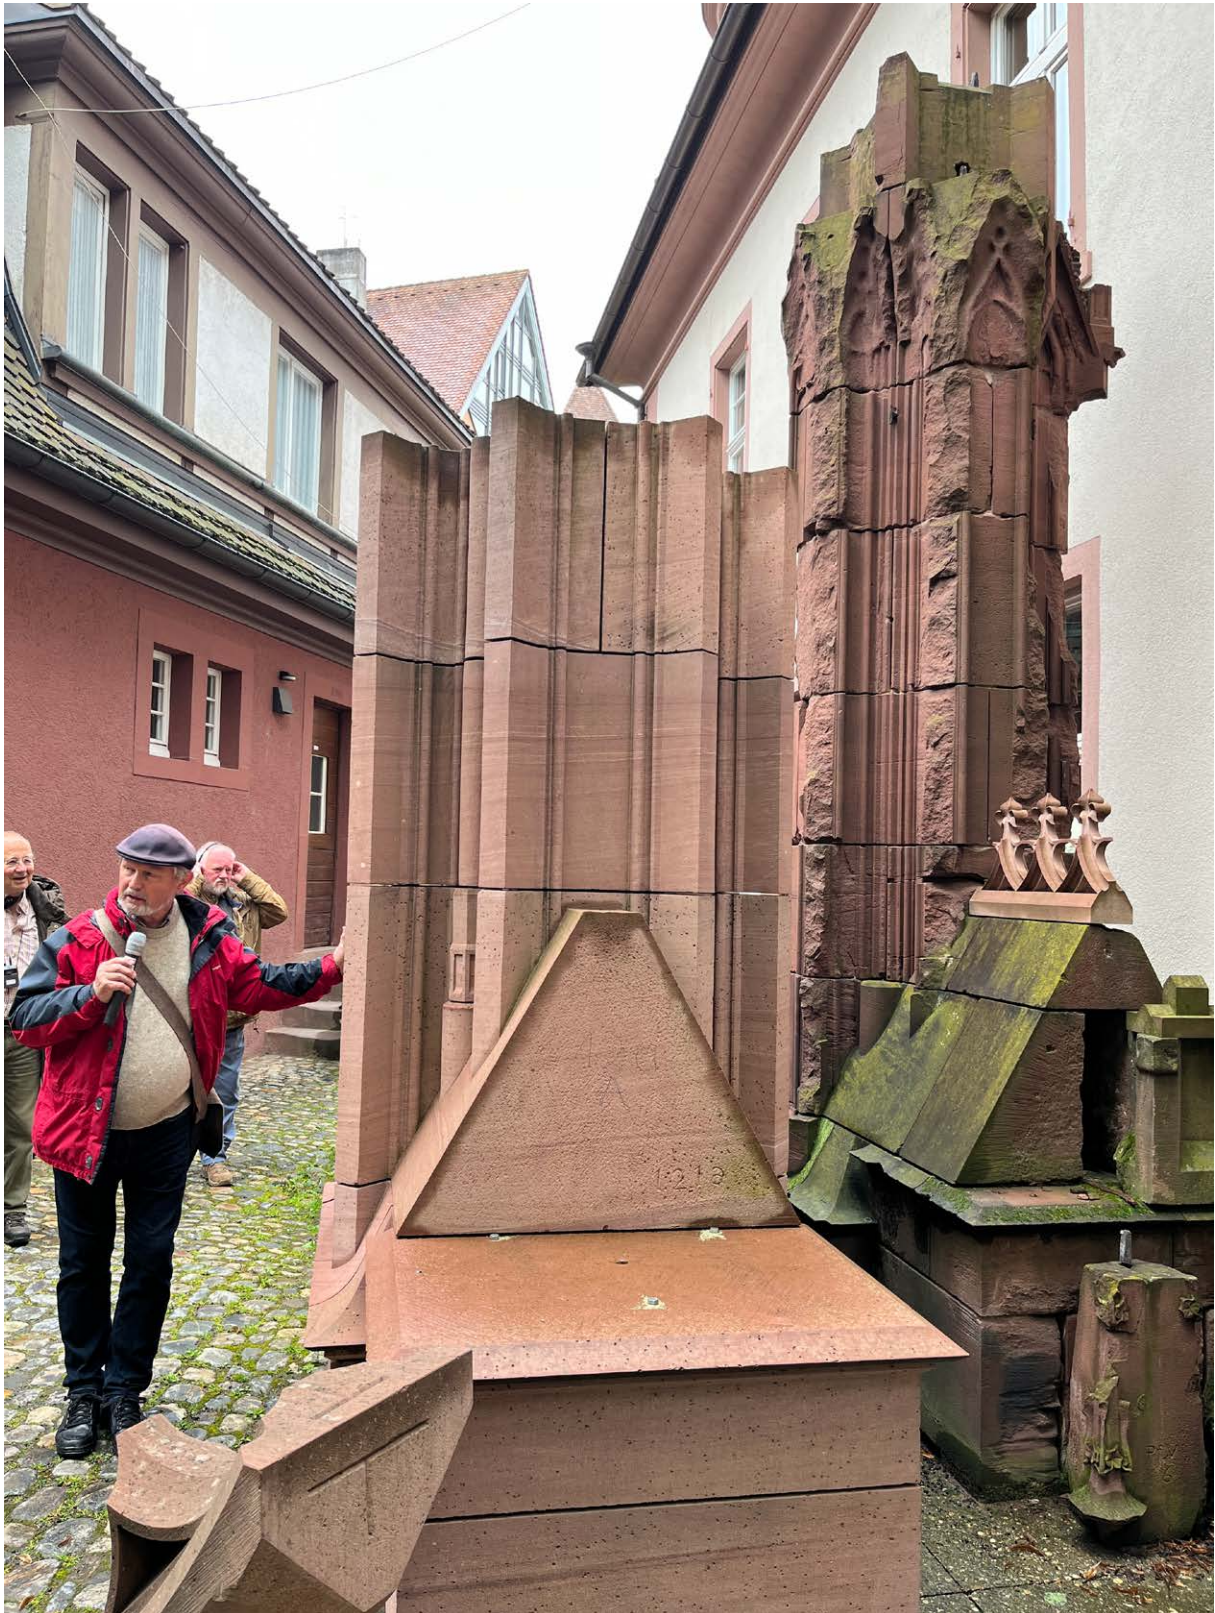
Figure 9. New pieces for the Freiburg Münster made of the sandstone from the reactivated quarry Tennenbach, to the right an old element of the Freiburg Münster made of the same sandstone, Dombauhütte (photo Angela Ehling).

As part of the extensive restoration work in our century, research into the historical quarries for Freiburg Münster was intensified and one of these quarries was reactivated in 2014. Since then, the sandstone from this quarry has been used again as a replacement material (Fig. 9) (Brehm *et al.*, 2022).

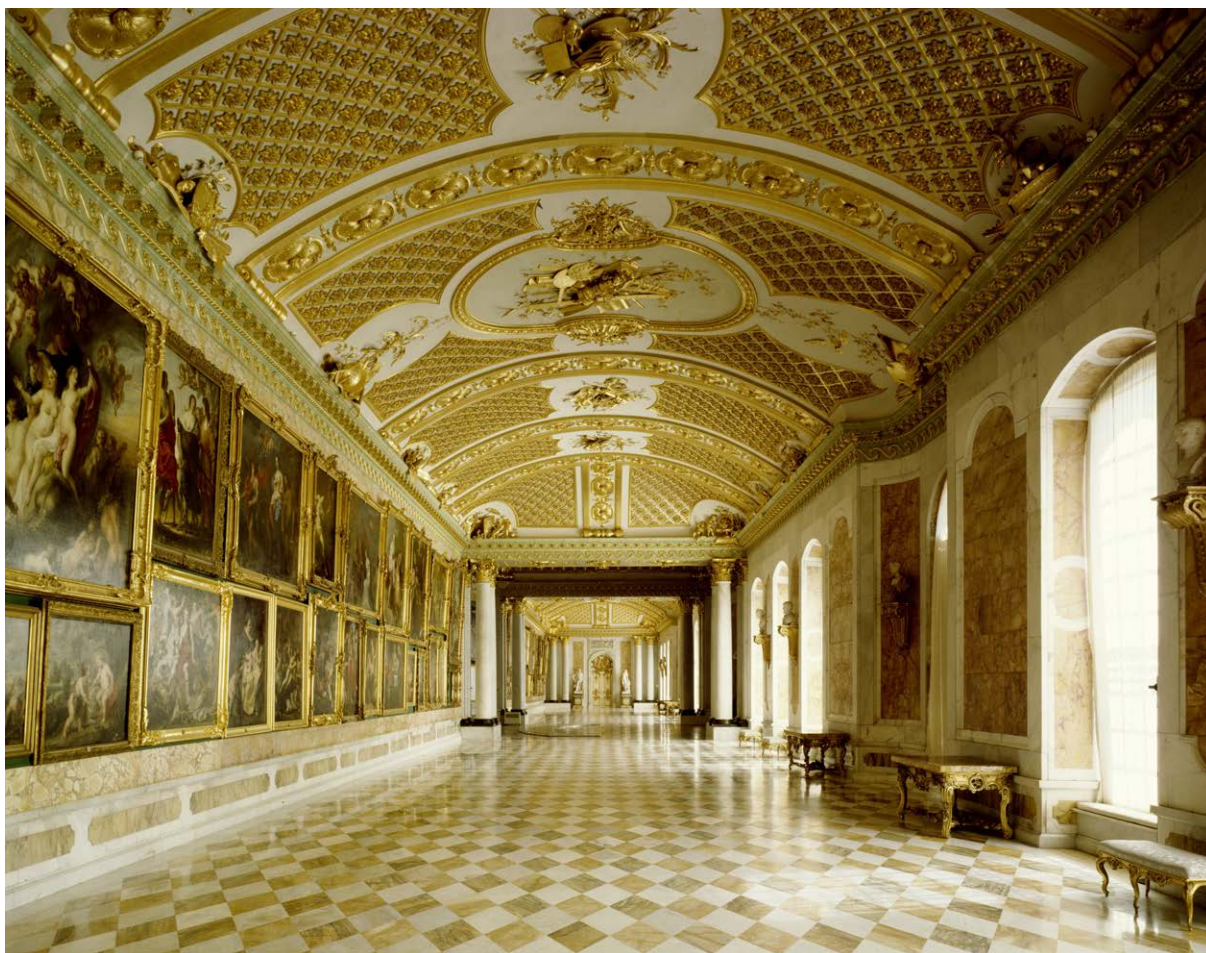
The Picture Gallery in Sanssouci Park (Fig. 10), which King Frederick II (the Great) of Prussia had built between 1755 and 1764, not only houses an excellent collection of paintings, but is also a particularly fine example of the diverse use of coloured natural stones in Potsdam's 18<sup>th</sup> century palaces.

Figure 10. Picture Gallery Potsdam, Park Sanssouci, © SPSPG, Michael Lüder, 2005.

Initially, scepticism was heard from there regarding the availability of the material in the required quality and quantity. With the support of two companies from Colle Val d'Elsa and Rosia, the targeted extraction of the marble and the cutting of the required 1,400 marble slabs of *Giallo* and *Brocatello di Siena* could be realised. By returning the floor to the originally intended colour combination -consisting of the old, preserved Carrara slabs and the material-identical reconstructed slabs from the two varieties of Siena marble - the picture gallery was able to regain its splendid 18<sup>th</sup> century spatial impression. The work was completed in 1996 (Fig. 10).
